2004 DL650

WIRING RECTIFICATION

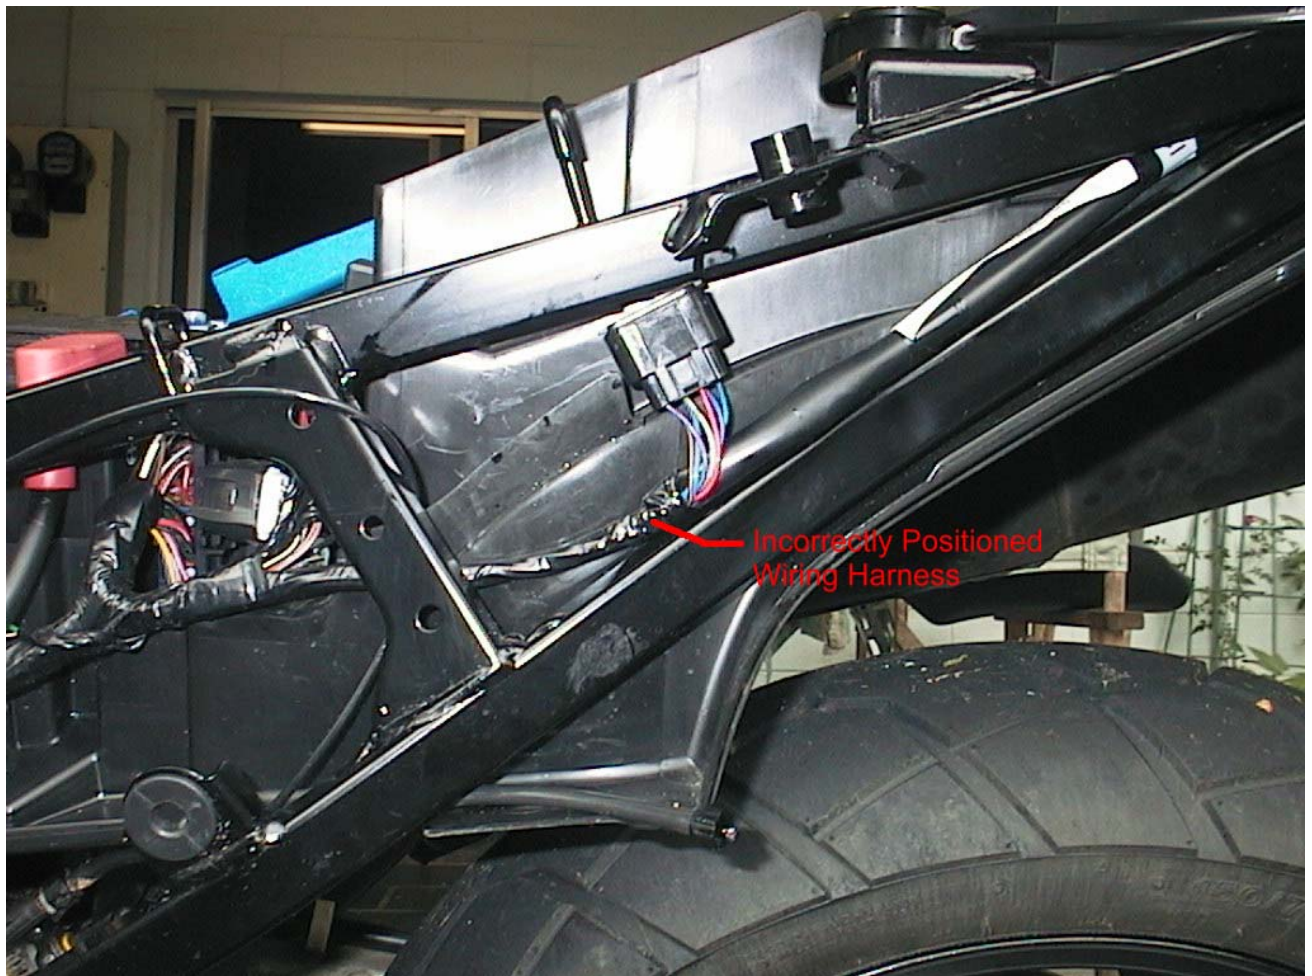
A possible minor recall problem has been found with the 2004 DL650. It has to do with the wiring harness to the rear taillights. On some bikes the wiring harness was not properly routed and, if left in position, could chafe through and cause a short circuit.

Figure 1 shows the wiring in the incorrect position. To get to this wiring harness, the left-hand black 'L' shaped side cover and the left-hand rear fairing piece must be removed.
